New Coating

Prevents Punch Ends from Ripping Off

Longer punch life keeps the presses running at this Connecticut automotive-parts supplier.

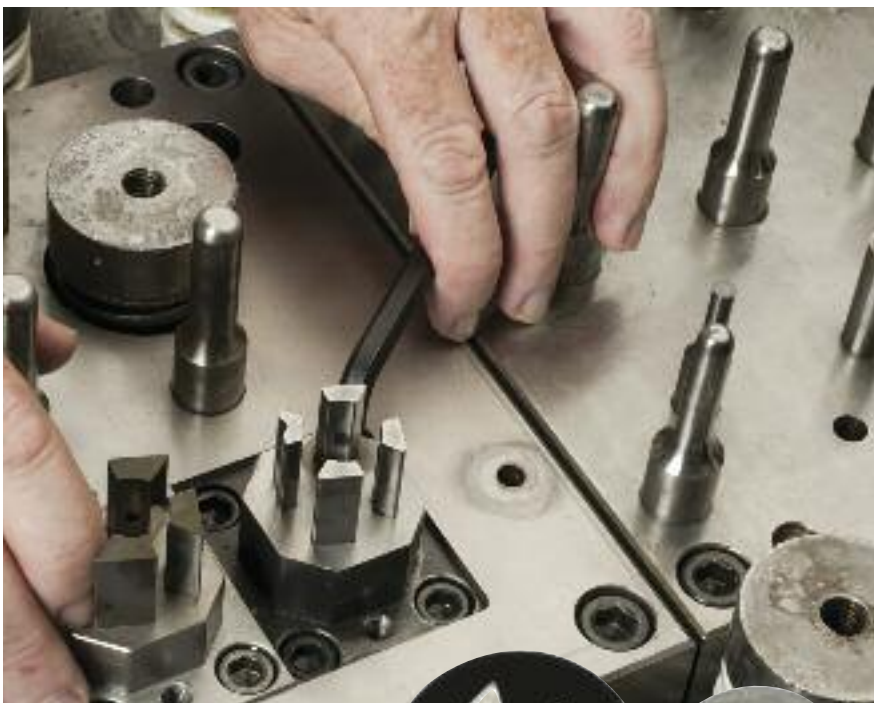
A change in tool coatings at Cowles Stamping increased punch life from 3000 to 16,000 hits between sharpenings when stamping HSLA-steel automotive parts.

Says Pelkey: “The coating allows us to produce an average of 16,000 stampings per run between sharpenings. And, we can resharpen the punches for continued life, which we could not do before.”
